Influence of the Wash From Bronze on the Weathering of Marble

National Bureau of Standards

Building Materials and Structures Report 137

Daniel W. Kessler and Ross E. Anderson

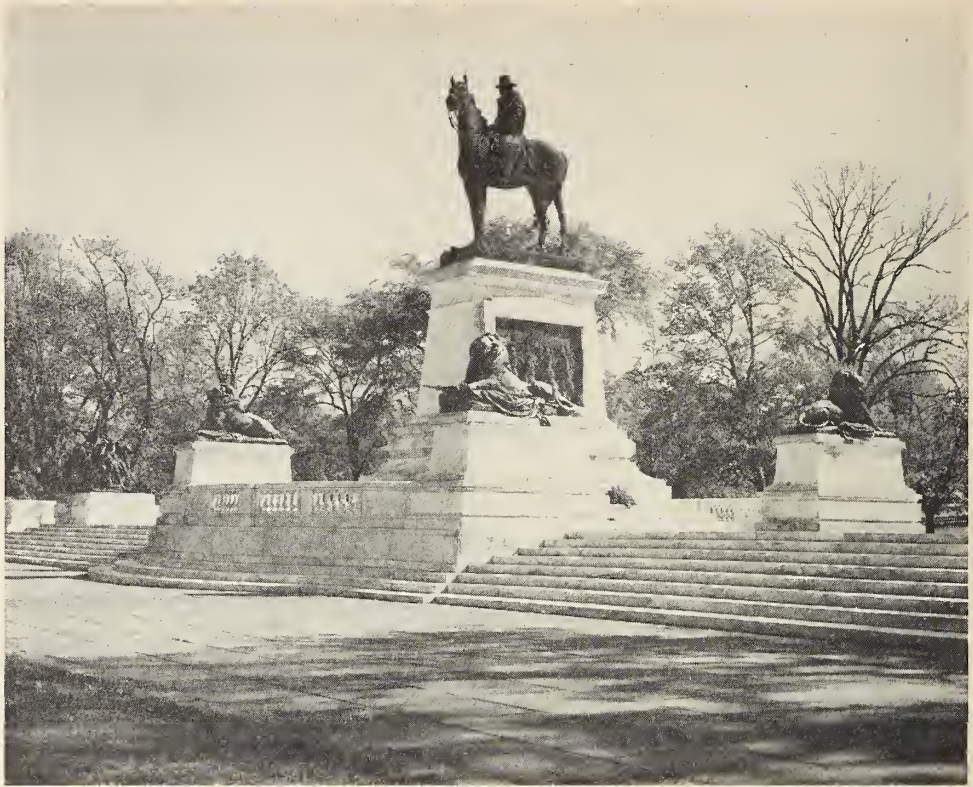
FIGURE 1. *Grant Monument, Washington, D. C., from the southwest showing all but one of the bronze groups and the supporting marble.*

Vermont White Marble: The Grant Monument (1922) shown in figure 1 consists of seven marble bases supporting large bronze figures. Several blocks have prominent brown stains, accompanied by cracking of the marble. The worst condition is shown in figure 3, but many blocks appear to be in good condition. The corner block under the south group is projecting considerably over the edge of the block below. This is believed to indicate that the injured block has undergone a swelling action.

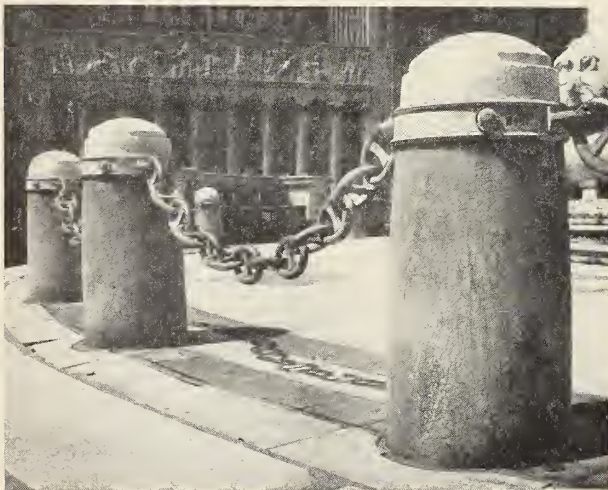
FIGURE 2. *Marble posts surrounding the McKinley Monument at Buffalo, N. Y.*

The marble below the bronze collars, forming an attachment for the chain, is badly cracked and discolored brown, whereas that part above the collars is not much changed.

The McKinley Monument, in Buffalo, N. Y. (1907), is surrounded by several marble posts, and near the top of each post is a bronze collar supporting a bronze chain. Figure 2 illustrates how seriously the marble is cracked. Above the collars the marble appears to be in good condition. When this structure was examined about 20 years ago, the brown stains were confined to a few inches below the collars, and incipient cracking was visible in these discolored areas. This seems to prove that the deterioration was caused by the bronze rather than some substance coming up from below.

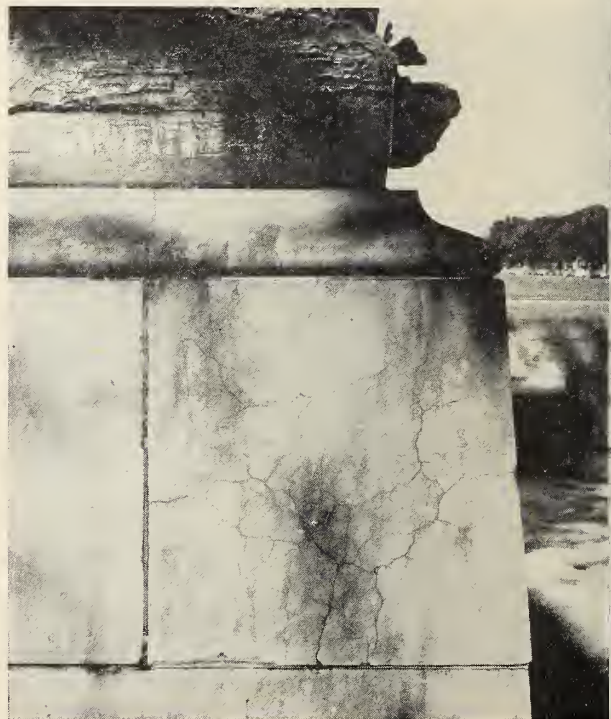
FIGURE 3. *Block of badly cracked marble under the north statuary group of the Grant Monument showing the worst condition in this structure.*

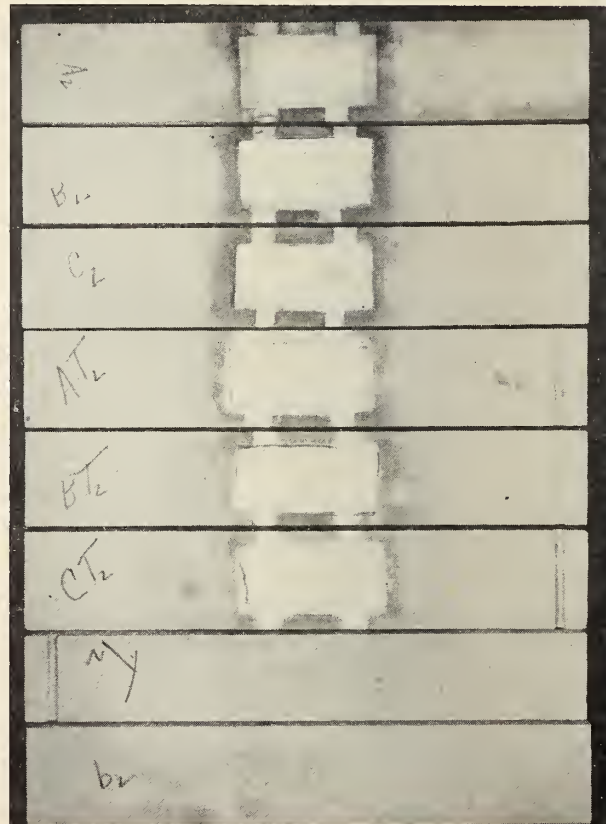
FIGURE 6. Various marble specimens after 10 years of exposure to bronze shavings.
The dark areas were brown, and immediately under the bronze, green discolorations occurred.

The specimens were examined periodically during the first 2 years for staining effects. Faint-green stains on the marble occurred within a year, and brown stains were noted after 18 months. The brown discolorations occurred mainly where there was little shading from the sun; the green appeared on the lower faces of the slabs, under the bronze shavings, and under the bronze strips used to secure the boxes to the marble. The darkest part of the brown stains extended about 2 in. from the boxes, as shown in figure 6, but in most cases the marble was appreciably darkened on the top face to the ends. The same kinds of stains occurred on the paraffin-treated marble as on the untreated, but the treatment appeared to retard the staining somewhat. At the end of 5 years there was no appreciable difference in the amount of discoloration on the treated and untreated marble.

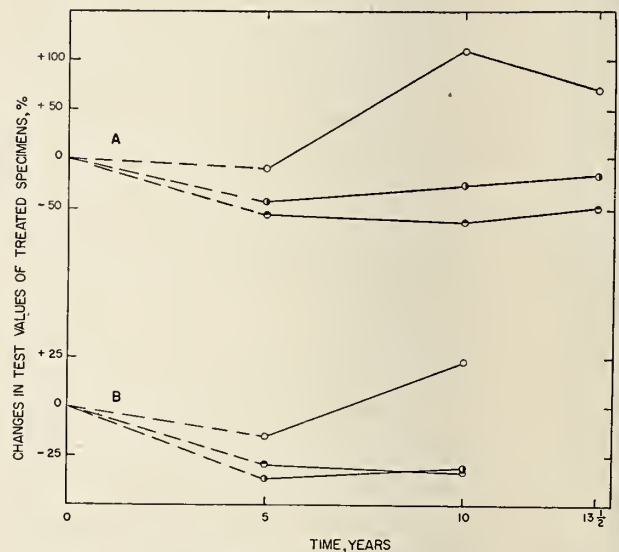
FIGURE 15. Changes in strength, abrasive hardness, and absorption of the treated specimens.

The treatment appeared to accelerate the weathering action rather than retard it.

Tests on paraffin-treated specimens were not planned in the original program, but some specimens were included at the request of the marble producer who supplied the specimens. The limited number of pieces precluded a more thorough study of the value of the treatment. It was known that this treatment was quite effective in sealing the pores of sandstones and limestones of the more porous varieties, and that the treatment deteriorated slightly during an exposure period of 10 years [2]. No previous data were available to indicate that the treatment reduces the strength and abrasive resistance of stone.

The effect of the treatment on strength was thought to be due to the wax acting as a lubricant between crystals. In order to check this assumption, some specimens were soaked in a light lubricating oil until it had penetrated entirely through the marble. Flexure tests were then made on the specimens, and the resulting modulus of rupture was 30 percent lower than the average for fresh untreated marble. As the fracture in this test is mainly between crystal surfaces, it is concluded that both the wax and oil caused a marked reduction in the bond between crystals.
